**Report of Dr. Brenton Cox
Regarding the May 31, 2017
Explosion at Didion Milling in
Cambria, Wisconsin**

March 31, 2023

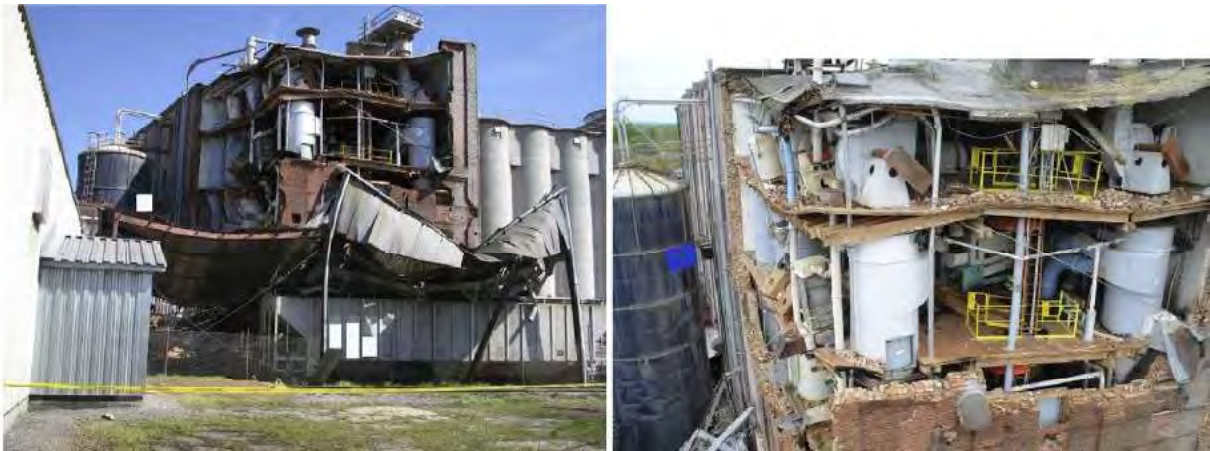
Figure 4. Photographs of the resulting damage from the explosion at the flour milling facility discussed in Smyth et al. (2019).⁴⁹

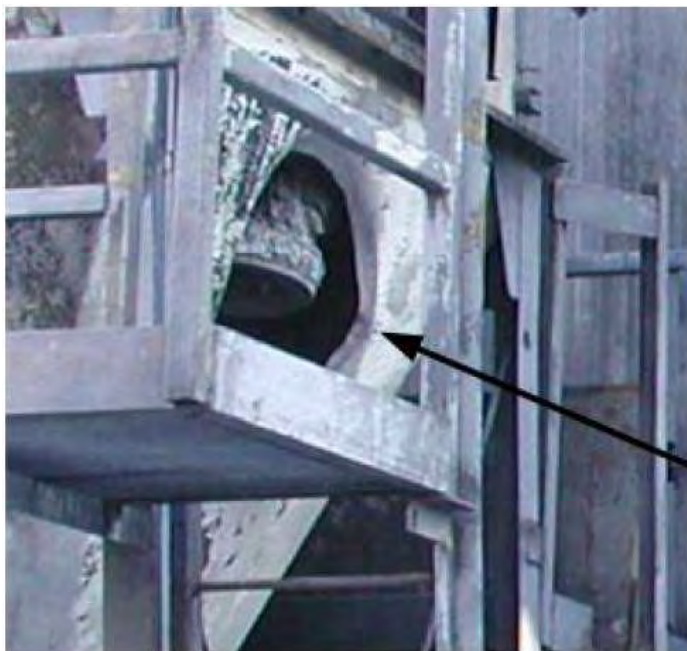
Figure 7. Photograph after the incident at Hayes Lemmerz International in 2003 indicating the short duct that used to connect the drop box to the dust collector before being pulled away by the propagating blast wave.⁵⁵

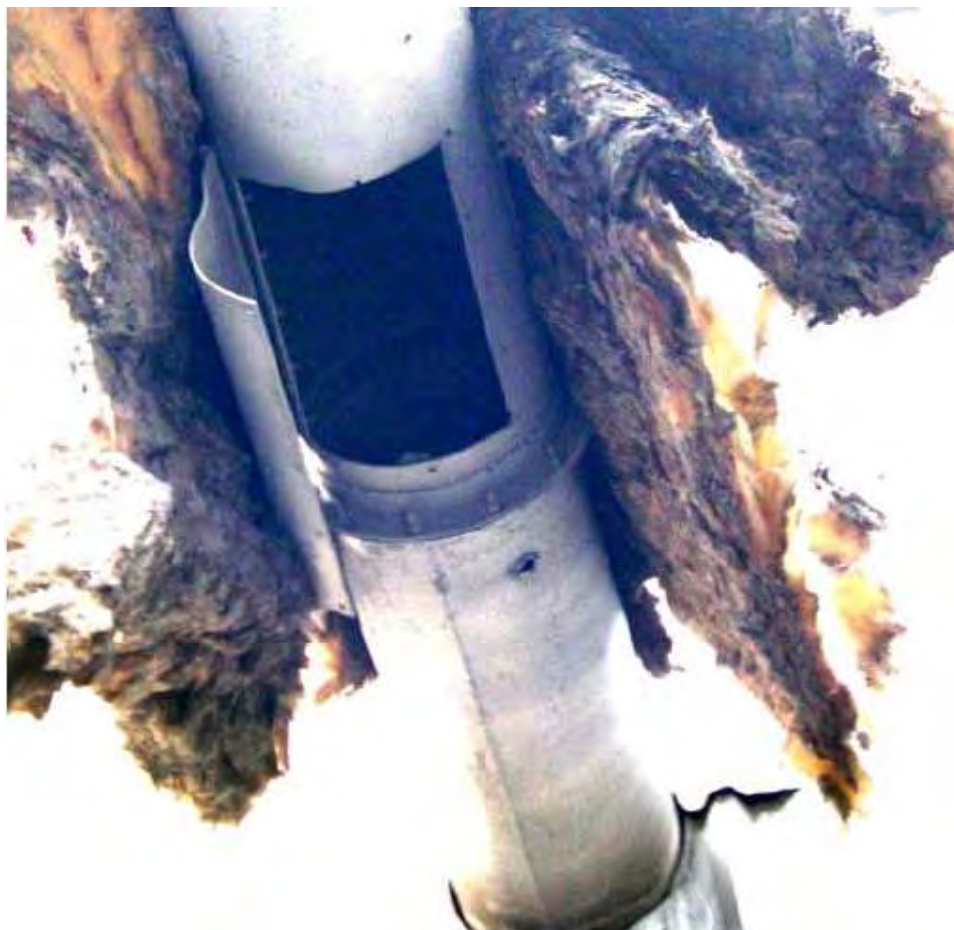
Figure 9. Cleanout door on the duct from a fume hood to fume separator. The door was blown open as a result of internal propagation during the incident at Hayes Lemmerz International in 2003.⁵⁷

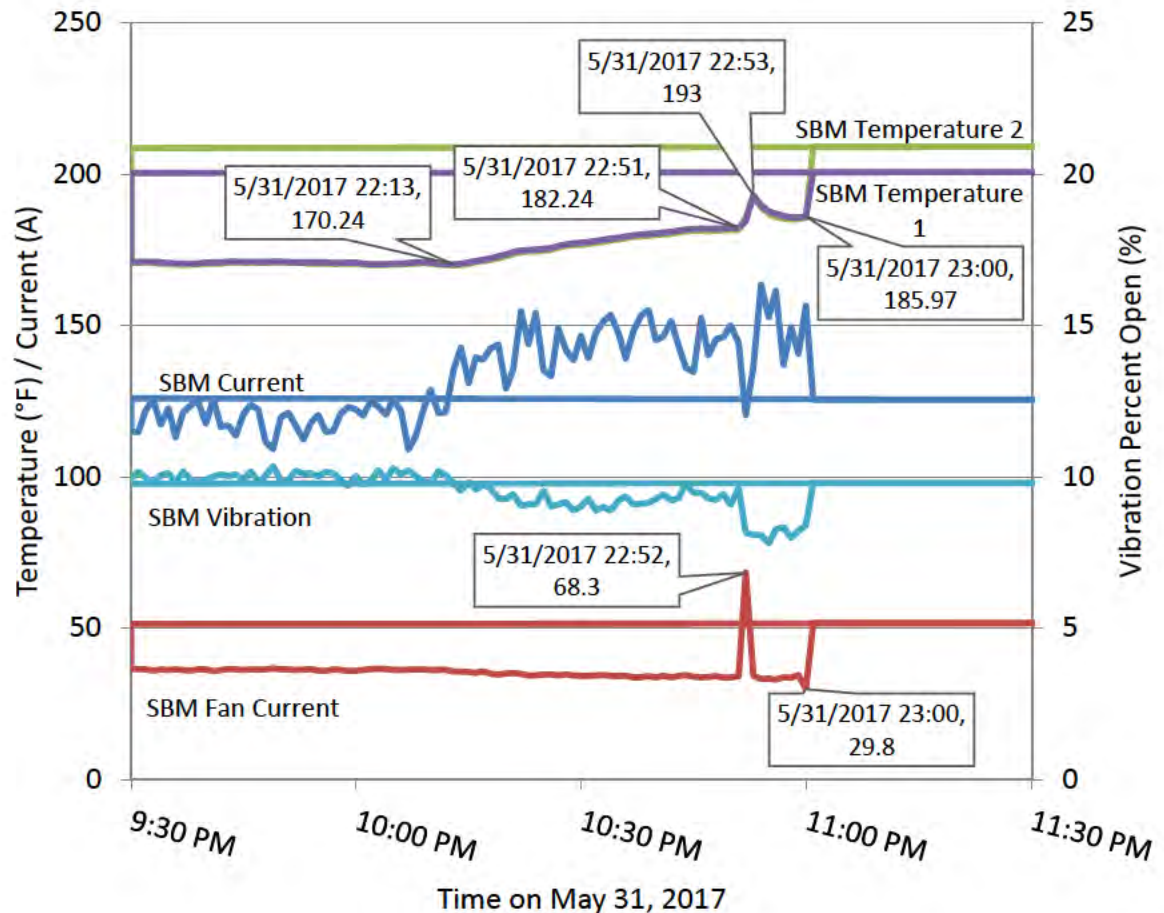
- At 10:13 PM, the temperature measured within the South Bauermeister began to rise at a gradual rate, increasing by approximately 12°F over the next 30 minutes, from 170°F to 182°F.
- At 10:45 PM, the temperature plateaued at approximately 182°F for the next 6 minutes.
- At 10:51 PM, the temperature spiked relatively sharply, increasing by 11°F in the 2 minutes between 10:51 PM and 10:53 PM, from 182°F to 193°F.
- At 10:53 PM, the temperature rapidly decayed from 193°F to 186°F over the remaining 7 minutes prior to the explosion.
- Between 11:00 PM and 11:01 PM, the temperature rose from 186°F to a temperature over 209°F (over the scale of the recording).

Figure 26. Temperatures, currents, and vibrations experienced by the South Bauermeister (SBM) on May 31, 2017.¹⁷⁵

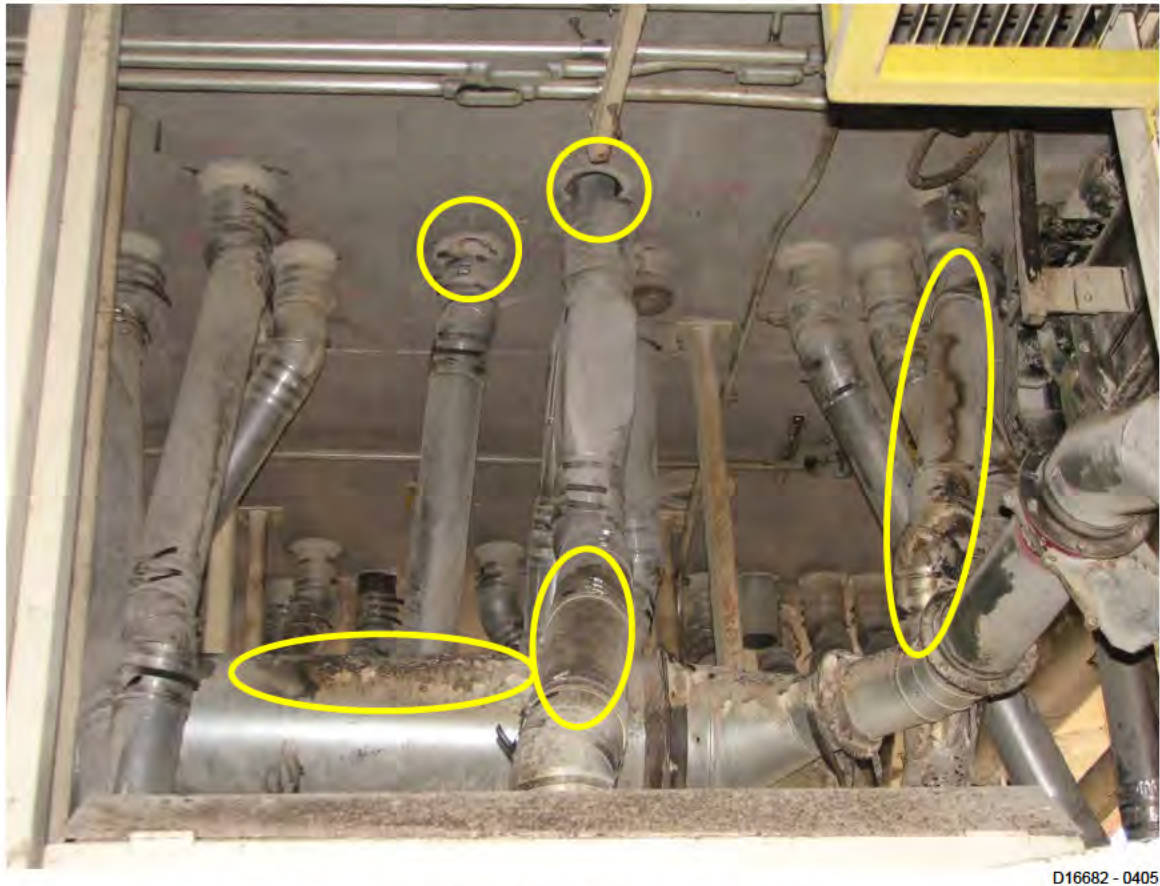
Figure 60. Post-incident view of ducting from the 6-section Bran Sifter in the ceiling of B3 that feeds into the North Bran Aspirator. The separated ducts and burn patterns of ejected product are clear evidence of internal overpressure.

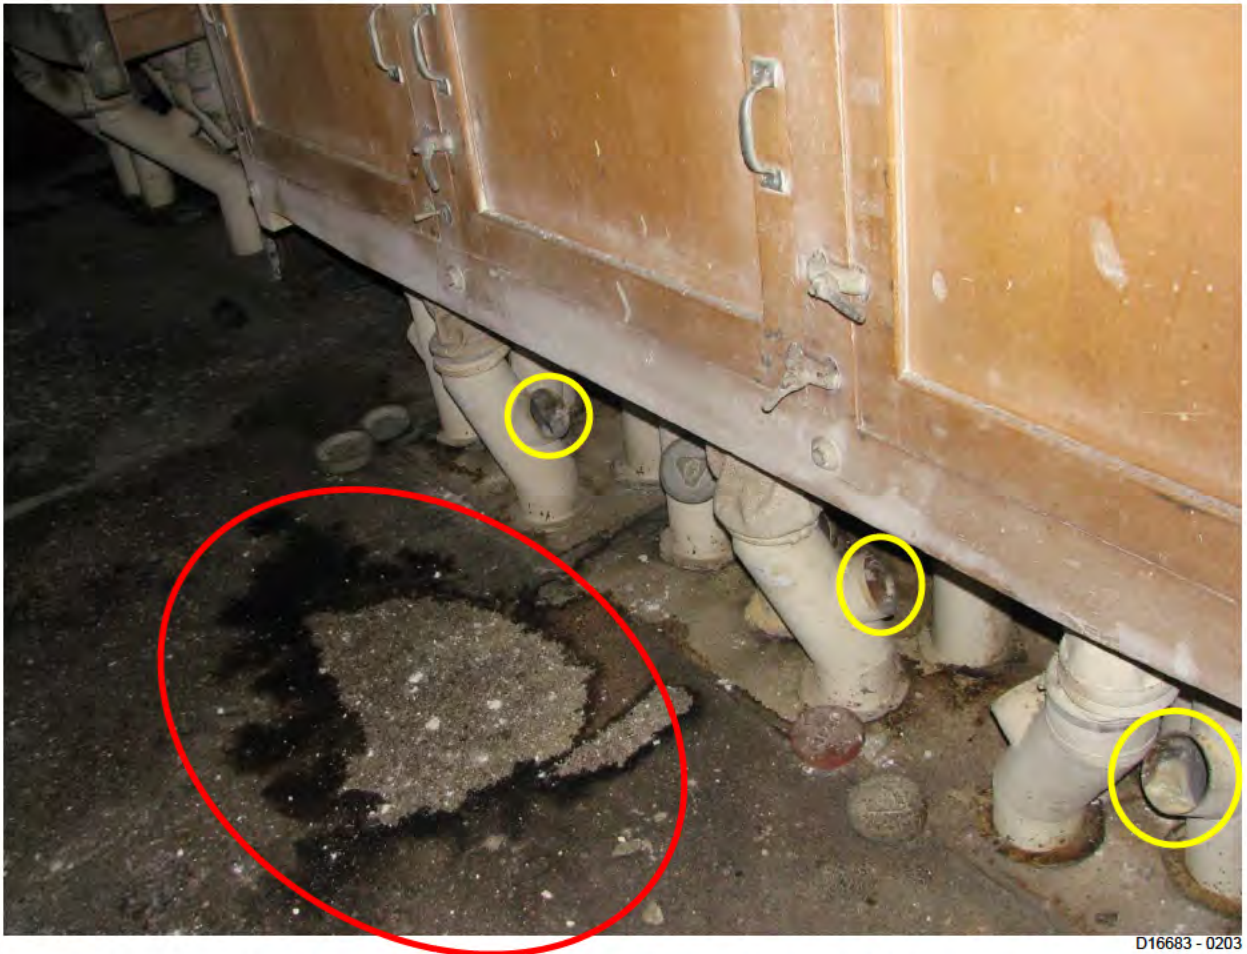
Figure 71. Post-incident view of 6-Section Sifter on 3rd floor of A-Mill with clear burn patterns on the ground and caps blown off ducts below the sifter going into the 2nd floor of the A-Mill.

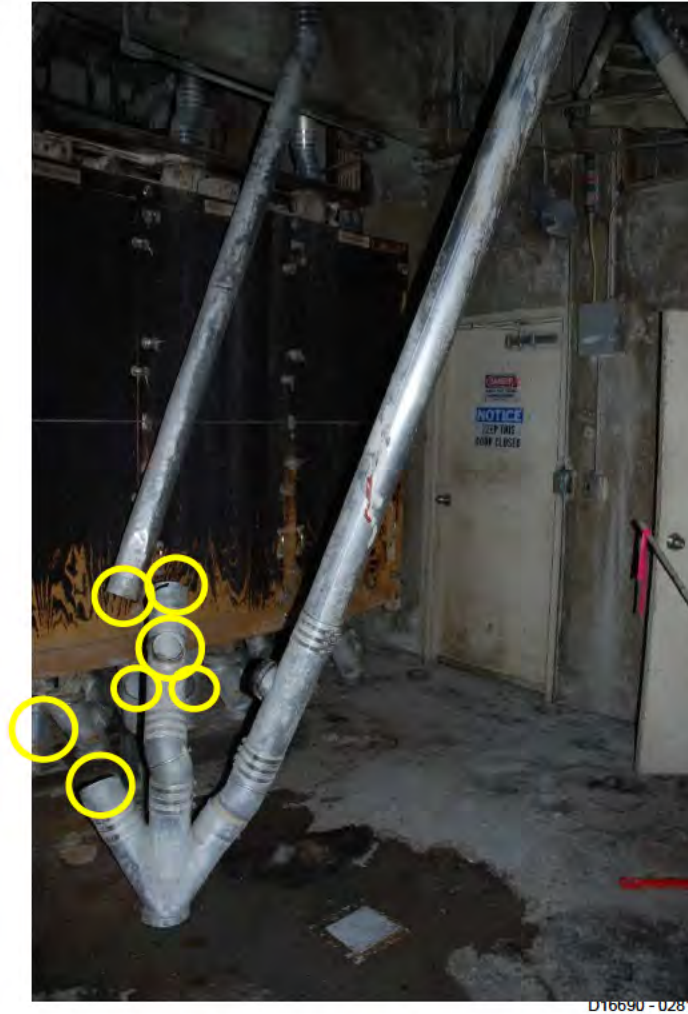
Figure 72. Post-incident view of the Grit/Flour Sifter (M-11021) on the 5th floor of the A-Mill. Yellow circles indicate detached ducts and caps as a result of internal overpressure.

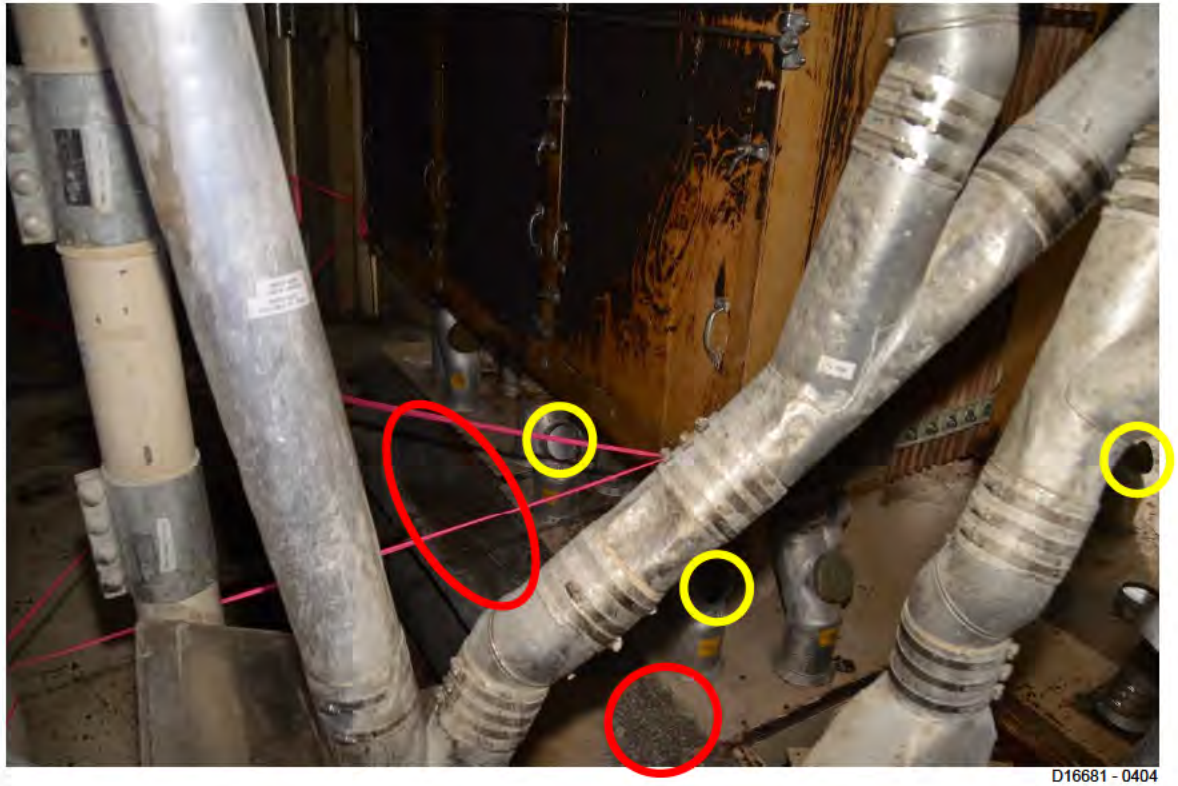
Figure 89. Post-incident view of A-Mill Sizing 6-section sifter (M-11014) on the 4th floor of the A-Mill with caps blown off due to internal pressure (yellow) and burns on the floor from ignited ejected product (red).

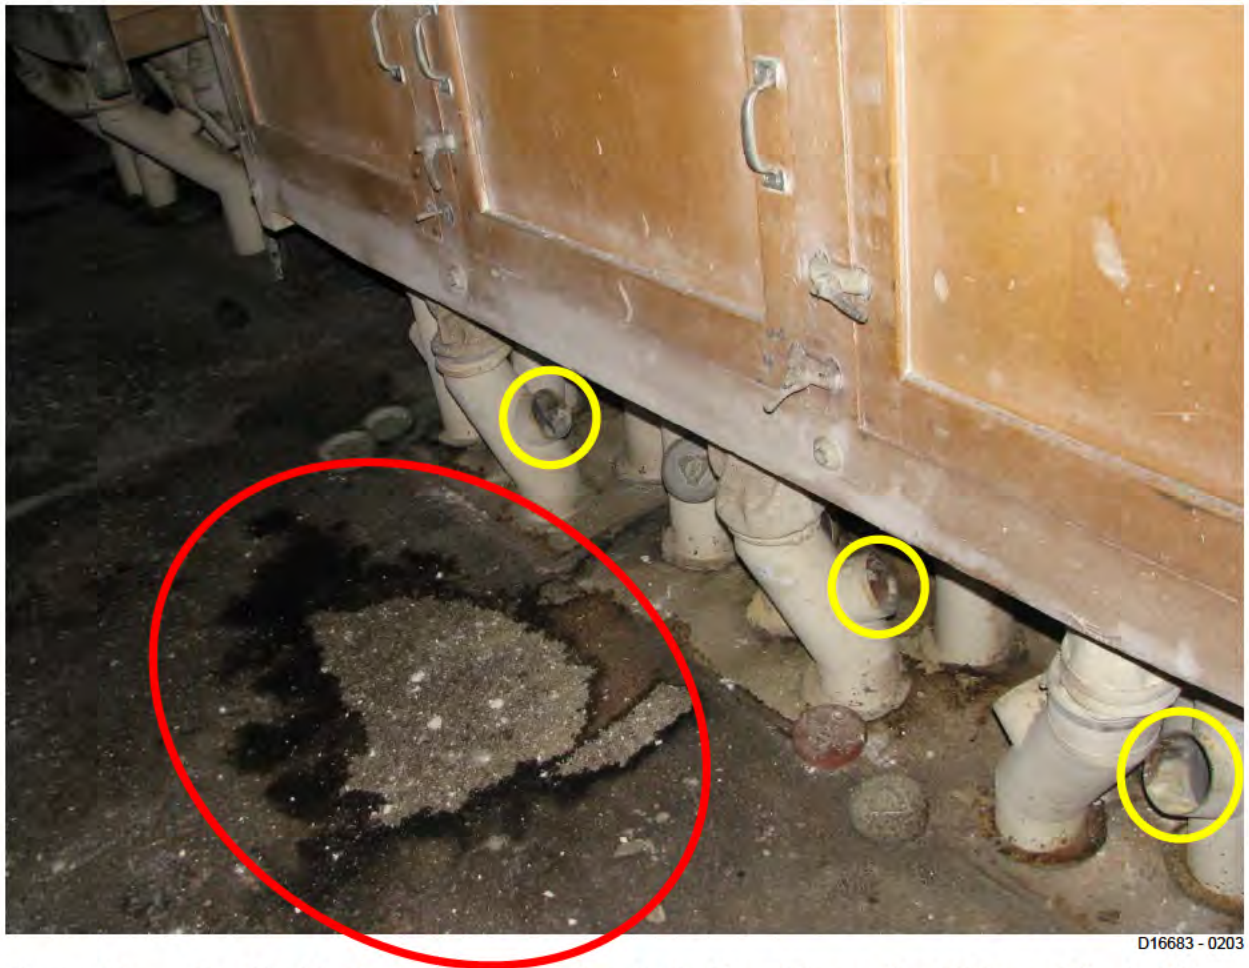
Figure 90. Post-incident view of Sizing Flour 6-Section Sifter on the 3rd floor of the A-Mill with caps blown off due to internal pressure (yellow) and burns on the floor from ignited ejected product (red).

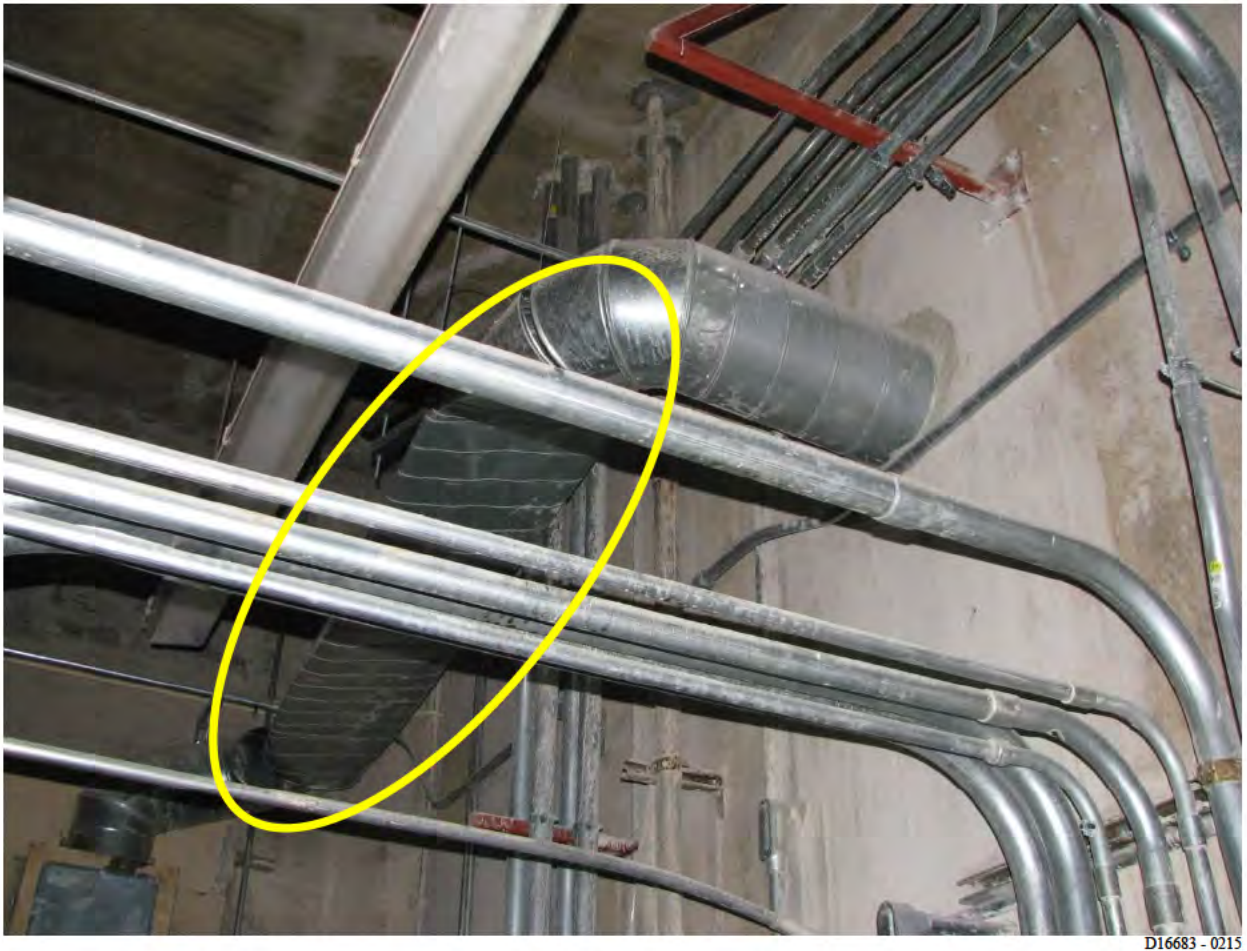
Figure 94. Post-incident view of collapsed duct from internal overpressure on the 3rd floor of the A-Mill.
